# Manhole Inspection Summary

Manhole # S63A\_\_003MH

**Location** Address: **5901 Lombard St.**

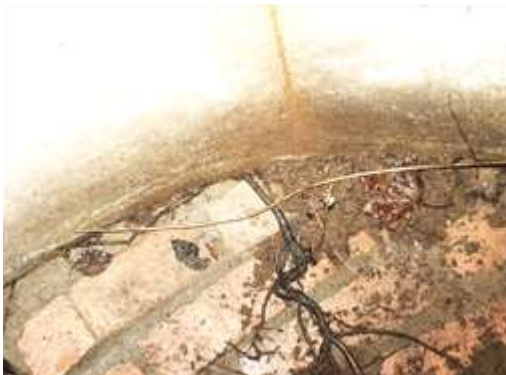
Defect 3

debris

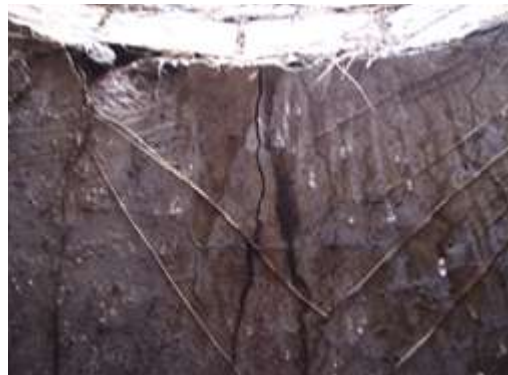
Defect 2

☒ **Root Intrusion**

☒ **Roots**

roots

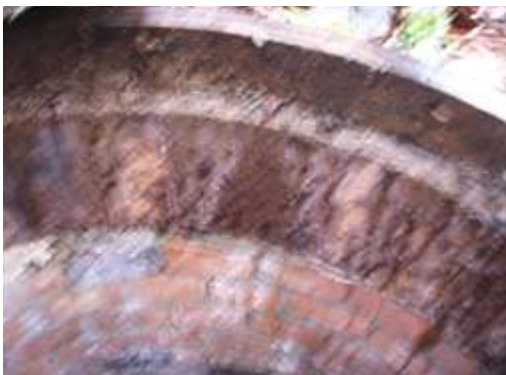
Defect 1

☒ **Leaks**

frame

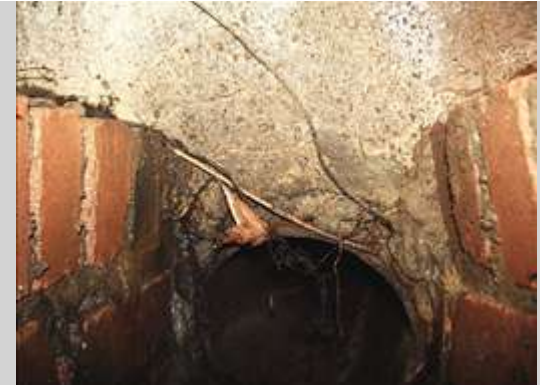
**12 O'Clock Outflow**

**72 in. Circular Gravity Sewer**  
**Pipe Out @ 12 O'Clock**

Pipe Height: **12** (in.) Rod and Bar (Angled)  
Pipe Material: **Unknown** ☐ Pipe Lined  
Invert Depth: **12.33** (ft.) Flow Characteristics: **Turbulent**  
Deposits: ☒ None ☐ Mud ☐ Sludge ☐ Debris ☐ Grease  
Silt Depth: (in.) Deposits Extent:  
Infiltration: **None** Pipe Seal Cond: **Sound**

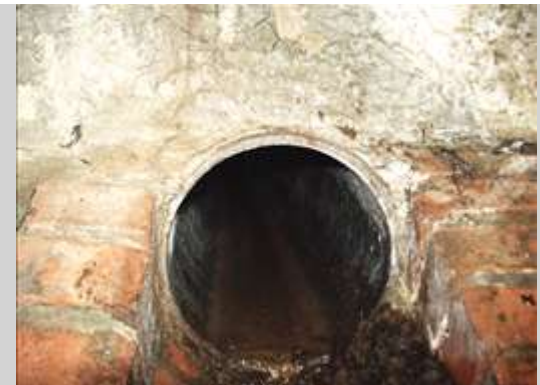
**4 O'Clock Inflow**

**8 in. Circular Gravity Sewer**  
**Pipe In @ 4 O'Clock**

Pipe Height: **12** (in.) Rod and Bar (Angled)  
Pipe Material: **Clay** ☐ Pipe Lined  
Invert Depth: **10.83** (ft.) Flow Characteristics: **Slow**  
Deposits: ☒ None ☐ Mud ☐ Sludge ☐ Debris ☐ Grease  
Silt Depth: (in.) Deposits Extent:  
Infiltration: **None** Pipe Seal Cond: **Sound**

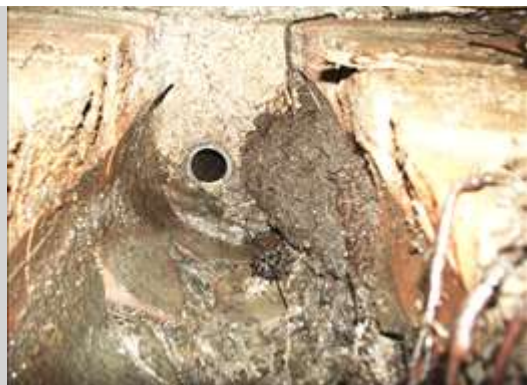
7 O'Clock Inflow

15 in. Circular Gravity Sewer  
Pipe In @ 7 O'Clock

Pipe Height: **4.8** (in.) Rod and Bar (Angled)

Pipe Material: **Clay** ☐ Pipe Lined

Invert Depth: **11.08** (ft.) Flow Characteristics: **None**
